EXPERIMENTAL STEEL PILE GROINS, PALM BEACH,
FLORIDA

11 May 1944

BEACH EROSION BOARD
OFFICE OF THE CHIEF OF ENGINEERS

TECHNICAL MEMORANDUM NO. 10

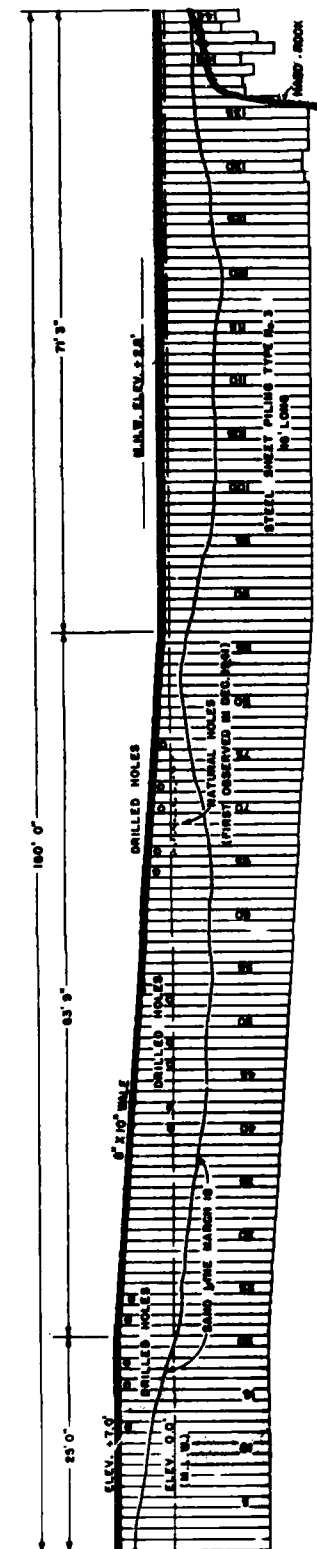
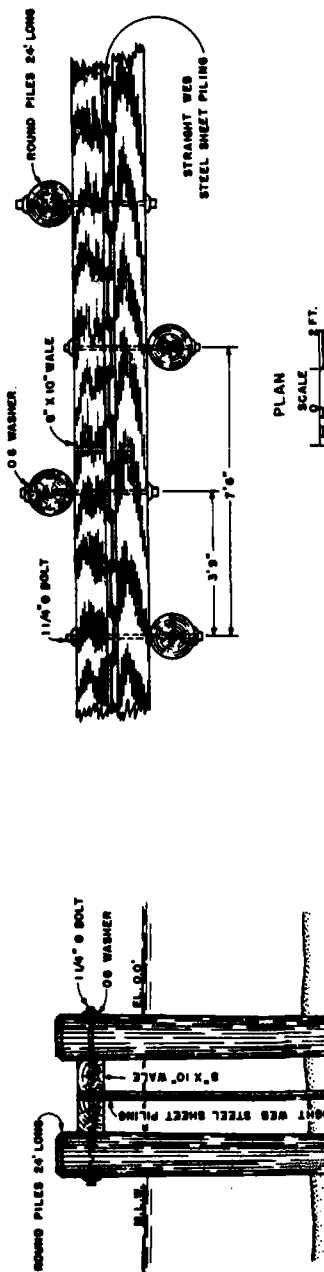
EXPERIMENTAL GROIN 131 N
FIG. 6

December 1941. For the first time holes are observed in the piles at the sand line in the interval between 81 and 92 feet from the bulkhead. See Figure 6. The outer 74 feet of wales are gone.

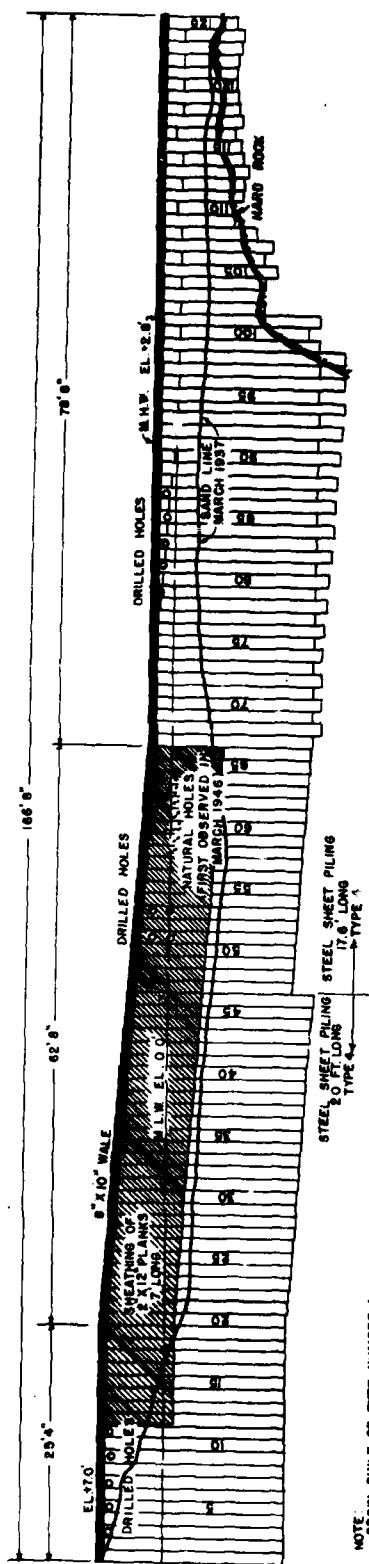
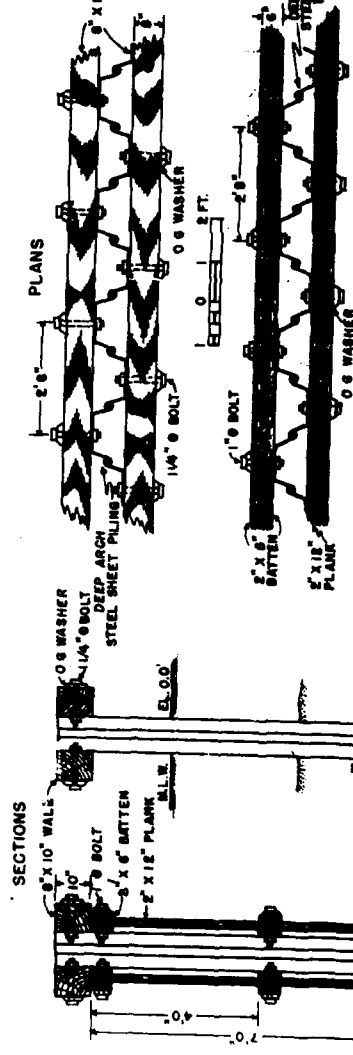
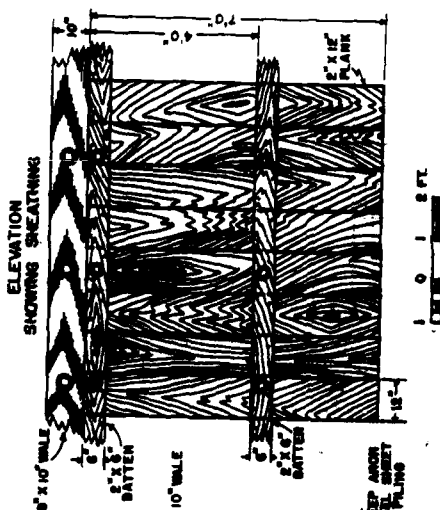
EXPERIMENTAL GROIN 121 N
FIG. 7

March 1946. The timber sheathing is gone beyond 65 feet from the bulkhead. Holes appear in the piling in the interval between 77 and 83 feet from the bulkhead. See Figure 7.

16. Wood Sheathing. The creosoted wood sheathing protecting Groin 121-N is shown on Figure 7. Three planks removed from the north side of the groin in order to measure the web thickness in August 1940 were not replaced. The sheathing did not afford complete protection to the piles because beach material was introduced into the space between the sheathing and the piles from the top of the groin by breaking waves. The smaller material, such as sand and shell, promptly washed out; but the stones and larger detritus remained to be agitated by water jetted through the spaces between the individual planks in the sheathing by wave action, thereby subjecting both the steel and the timber to wear from this source. The condition of the sheathing in August 1940 is shown on the upper photograph of Figure 12. The wood sheathing apparently protected the steel piling effectively over the first 5 years, after which it deteriorated rather rapidly. As shown by the lower photograph of Figure 12, by June 1946 the sheathing had become completely ineffective and all that remained were knife-edged stalagmite-shaped pieces of wood which projected above the sand line.

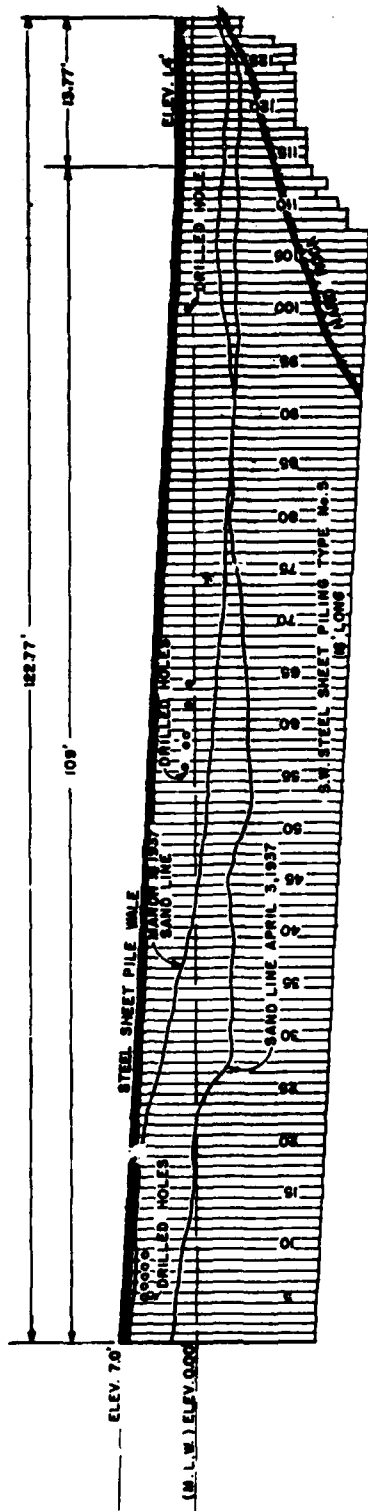
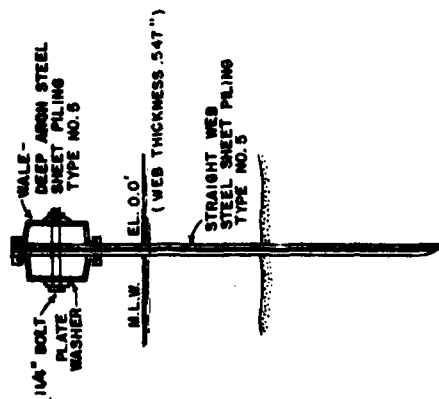
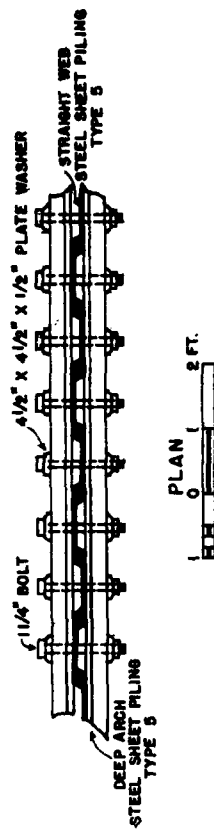
EXPERIMENTAL GROIN 112 N
FIG. 8

(Figure 8) built of 0.547-inch steel had no holes up to March 1946 although holes were observed in April 1948. The dates when holes were first observed in the groins, the time elapsed, the approximate location of the center of the naturally perforated area, the number of years elapsed from installation until the holes were first observed and the annual reduction in web thickness of the steel on this basis are given in the lower portion of Table 2.

17. Protective Coatings. The commercial and government specified coatings used on Groins 139-N (Figure 4) and 112-N (Figure 8) disappeared from the exposed portion of the piles for all practical purposes in less than six months.
